# Microbiological contamination of reinforced concrete structures in the poultry complex

**The object of research** is a microbiological contamination of reinforced concrete structures of the poultry house. **Method.** The species composition of microorganisms settled on the selected samples of reinforced concrete structures was determined in laboratory conditions. The identification of microscopic fungi was carried out according to their morphological and cultural characteristics using determinants: K. B. Raper, C. A. Thorn, 1949; K.B. Raper, D.I. Fennel, 1965; N.P. Podopilchenko (1971); M.A. Litvinov (1967); A.A. Milko (1974); T.C. Кириленко (1977); K. Donch, V. Gams, 1980; A.U. Lugauskas, A.N. Mikulskene, D.U. Shlyauzhene (1987); V.I. Bilay, E.Z. Koval (1988). **Results.** Biodegradation processes in buildings with different service lives are considered. Biodegraders that affect biodegradation of concrete and reinforced concrete structures have been identified.

To identify the presence and study of the nature of microbiological contamination, poultry buildings of Avangard LLC poultry farm in Ruzaevsky district were studied. The very first buildings were built more than 50 year

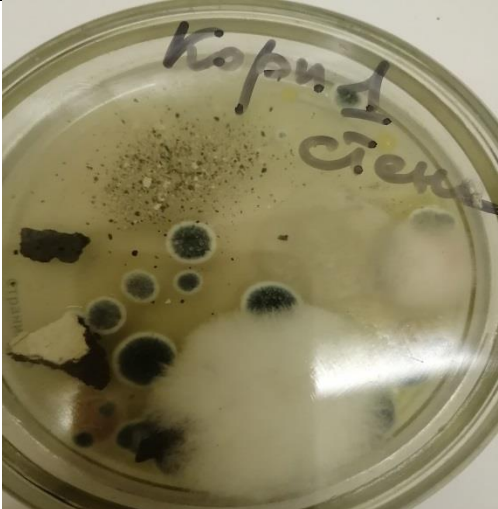
No.	Sample number	Species composition of microorganisms isolated from the surfaces of taken samples	Photos of fungi from concrete surface
1	Sample 1 (wall)	<p><i>Alternaria alternata</i>,  <i>Penicillium chrysogenum</i>,  <i>Penicillium claviforme</i>,  <i>Penicillium notatum</i>,  <i>Penicillium lanosum</i>,  <i>Paecilomyces variotii</i>,  <i>Fusarium moniliforme</i></p>

Mycobiota of the surface of reinforced concrete structures of poultry building 1, maintained for 11 years (Table 1), is represented by 14 species from 8 genera: 3 species of *Alternaria* (*Alternaria alternata*, *Alternaria brassicae*, *Alternaria solani*), 1 species of *Aspergillus* genus (*Aspergillus oryzae*), 4 species of *Penicillium* (*Penicillium lanosum*, *Penicillium claviforme*, *Penicillium chrysogenum*, *Penicillium notatum*), 1 species of *Paecilomyces* genus (*Paecilomyces variotii*), 1 species of *Fusarium* genus (*Fusarium moniliforme*), 2 species of *Cladosporium* genus (*Cladosporium herbarum*, *Cladosporium elatum*), 1 species of *Chaetomium* genus (*Chaetomium dolichotrichum*), 1 species of *Mucor* genus (*Mucor corticola*). The results of the studies showed that among the fungi contaminating the surface of the presented concrete samples, fungi of *Alternaria*, *Penicillium*, *Cladosporium*, *Fusarium* and *Mucor* genus are the most common. Dominant species identified from various sections of reinforced concrete structures of poultry building 1 are such fungi as *Alternaria alternata*, *Penicillium lanosum*, *Penicillium chrysogenum*, *Fusarium moniliforme*.

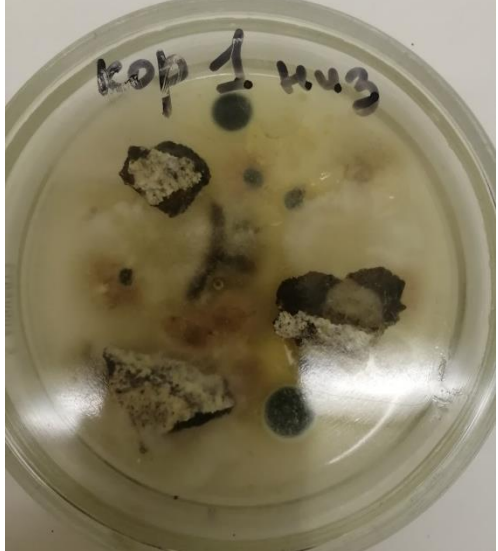
2	Sample 1 (bottom)	<p><i>Alternaria alternata</i>,  <i>Alternaria solani</i>,  <i>Penicillium chrysogenum</i>,  <i>Penicillium notatum</i>,  <i>Penicillium lanosum</i>,  <i>Fusarium moniliforme</i>,  <i>Cladosporium elatum</i>,  <i>Mucor corticola</i></p>

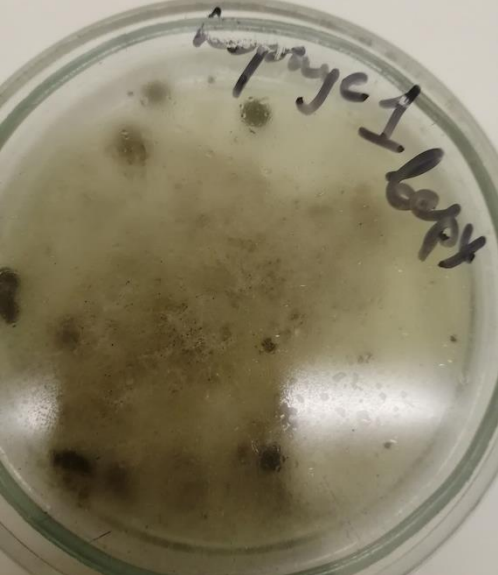
3	Sample 1 (top)	<p><i>Aspergillus oryzae</i>,  <i>Alternaria alternata</i>,  <i>Alternaria brassicae</i>,  <i>Fusarium moniliforme</i>,  <i>Penicillium lanosum</i>,  <i>Cladosporium herbarum</i>,  <i>Cladosporium elatum</i>,  <i>Chaetomium dolichotrichum</i>,  <i>Mucor corticola</i></p>

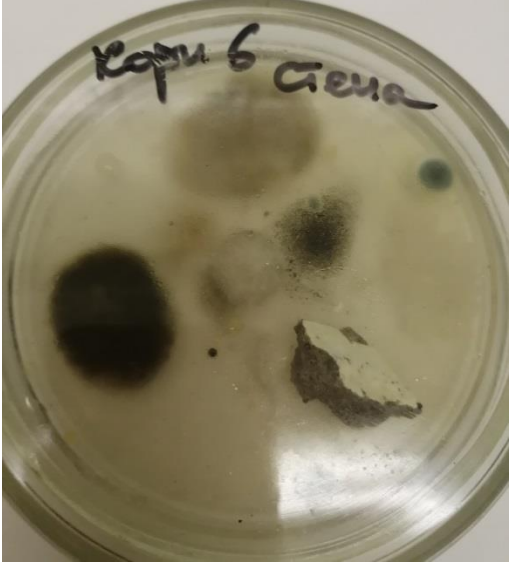
No.	Sample number	Species composition of microorganisms isolated from the surfaces of taken samples	Photos of fungi from concrete surface
1	Sample 6 (wall)	<i>Aspergillus niger</i> , <i>Alternaria alternata</i> , <i>Alternaria brassicae</i> , <i>Penicillium corylophilum</i> , <i>Penicillium lanosum</i> , <i>Penicillium chrysogenum</i> , <i>Penicillium cyclopium</i> , <i>Cladosporium elatum</i> , <i>Chaetomium dolichotrichum</i> , <i>Fusarium moniliforme</i>

Mycobiota of the surface of reinforced concrete structures of poultry building number 6, maintained for 16 years (Table 2), is represented by 14 species from 7 genus: 2 species of *Alternaria* genus (*Alternaria alternata*, *Alternaria brassicae*), 2 species of *Aspergillus* genus (*Aspergillus niger*, *Aspergillus terreus*), 6 species of *Penicillium* genus (*Penicillium lanosum*, *Penicillium corylophilum*, *Penicillium chrysogenum*, *Penicillium urticae*, *Penicillium cyclopium*, *Penicillium notatum*), 1 species of *Fusarium* genus (*Fusarium moniliforme*), 1 species of *Cladosporium* genus (*Cladosporium elatum*), 1 species of *Chaetomium* genus (*Chaetomium dolichotrichum*), 1 species of *Mucor* genus (*Mucor corticola*). Among the fungi contaminating the surface of concrete structures of building 6, the most common fungi are the genera *Aspergillus*, *Alternaria*, *Penicillium*, *Chaetomium*, *Cladosporium*, *Fusarium* and *Mucor*. The dominant species isolated from the reinforced concrete structures of poultry building 6 are micromycetes: *Aspergillus niger*, *Alternaria alternata*, *Penicillium chrysogenum*, *Penicillium corylophilum*, *Chaetomium dolichotrichum*, *Fusarium moniliforme*.

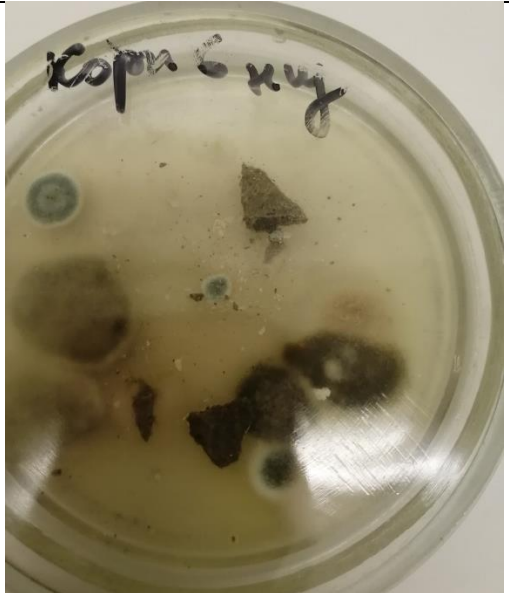
2	Sample 6 (bottom)	<i>Aspergillus terreus</i> , <i>Alternaria alternata</i> , <i>Penicillium chrysogenum</i> , <i>Penicillium corylophilum</i> , <i>Fusarium moniliforme</i> , <i>Chaetomium dolichotrichum</i> , <i>Mucor corticola</i>

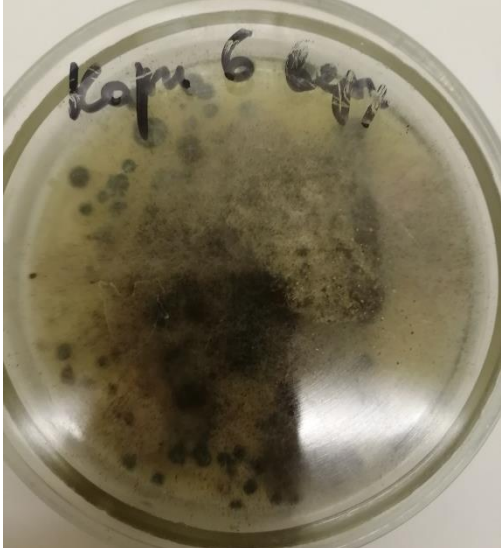
3	Sample 6 (top)	<p><i>Aspergillus niger</i>,  <i>Alternaria brassicae</i>,  <i>Penicillium chrysogenum</i>,  <i>Penicillium corylophilum</i>,  <i>Penicillium lanosum</i>,  <i>Penicillium urticae</i>,  <i>Penicillium notatum</i>,  <i>Cladosporium elatum</i>,  <i>Chaetomium dolichotrichum</i>,  <i>Mucor corticola</i></p>

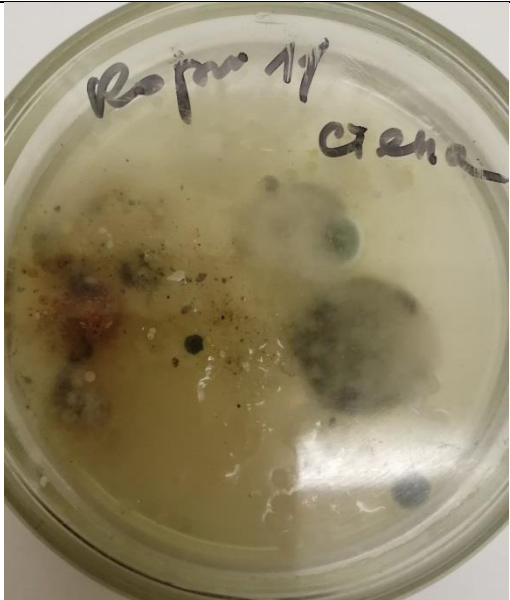
No.	Sample number	Species composition of microorganisms isolated from the surfaces of taken samples	Photos of fungi from concrete surface
1	Sample 11 (wall)	<p><i>Aspergillus ustus</i>,  <i>Aspergillus terreus</i>,  <i>Alternaria brassicae</i>,  <i>Penicillium chrysogenum</i>,  <i>Penicillium corylophilum</i>,  <i>Penicillium lanosum</i>,  <i>Penicillium expansum</i>,  <i>Fusarium moniliforme</i>,  <i>Paecilomyces variotii</i>,  <i>Cladosporium elatum</i>,  <i>Chaetomium dolichotrichum</i></p>

The species composition of micromycetes isolated from the surface of reinforced concrete structures of poultry building 11 maintained for 31 year (Table 3) is represented by 16 species from 8 genus: 2 species of *Alternaria* genus (*Alternaria alternata*, *Alternaria brassicae*), 3 species of *Aspergillus* genus (*Aspergillus ustus*, *Aspergillus oryzae*, *Aspergillus terreus*), 6 species of *Penicillium* genus (*Penicillium lanosum*, *Penicillium corylophilum*, *Penicillium chrysogenum*, *Penicillium claviforme*, *Penicillium expansum*, *Penicillium notatum*), 1 species of *Paecilomyces* genus (*Paecilomyces variotii*), 1 species of *Fusarium* genus (*Fusarium moniliforme*), 1 species of *Cladosporium* genus (*Cladosporium elatum*), 1 species of *Chaetomium* genus (*Chaetomium dolichotrichum*), 1 species of *Mucor* genus (*Mucor corticola*). Among the fungi contaminating the surface of concrete structures of building 11, the fungi of *Aspergillus*, *Alternaria*, *Penicillium*, *Cladosporium*, *Fusarium* genus are the most common. Dominant species isolated from reinforced concrete structures of poultry building 11 are micromycetes: *Alternaria brassicae*, *Penicillium lanosum*, *Cladosporium elatum*, *Fusarium moniliforme*.

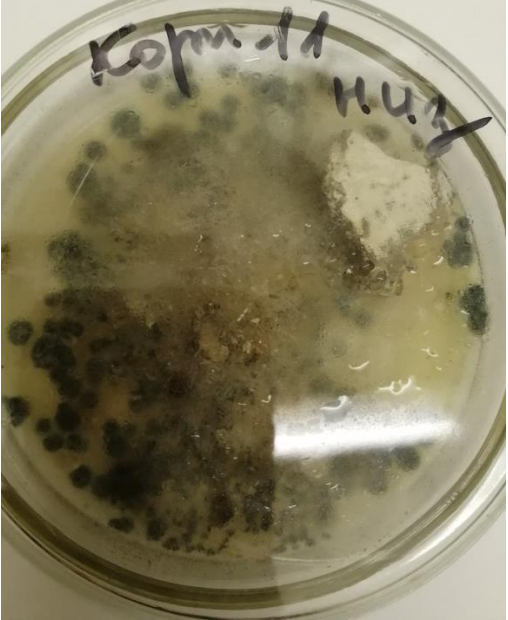
2	Sample 11 (bottom)	<p><i>Alternaria brassicae</i>,  <i>Penicillium notatum</i>,  <i>Penicillium corylophilum</i>,  <i>Penicillium lanosum</i>,  <i>Fusarium moniliforme</i>,  <i>Cladosporium elatum</i>,  <i>Mucor corticola</i></p>

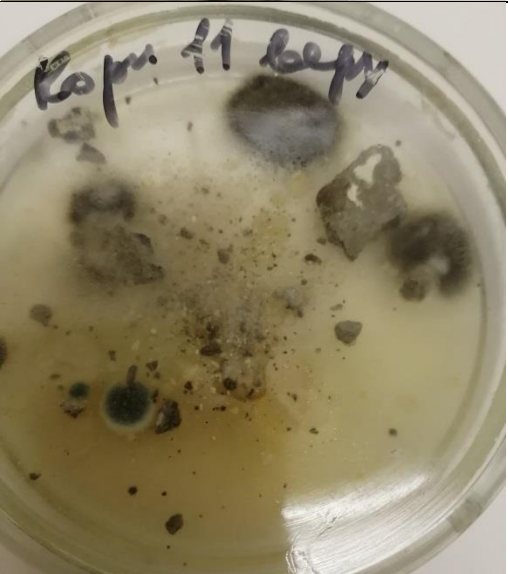
3	Sample 11 (top)	<p><i>Aspergillus oryzae</i>,  <i>Alternaria brassicae</i>,  <i>Alternaria alternata</i>, <i>Penicillium</i>  <i>chrysogenum</i>, <i>Penicillium</i>  <i>claviforme</i>, <i>Penicillium</i>  <i>lanosum</i>,  <i>Cladosporium elatum</i>,  <i>Chaetomium dolichotrichum</i>,  <i>Fusarium moniliforme</i></p>

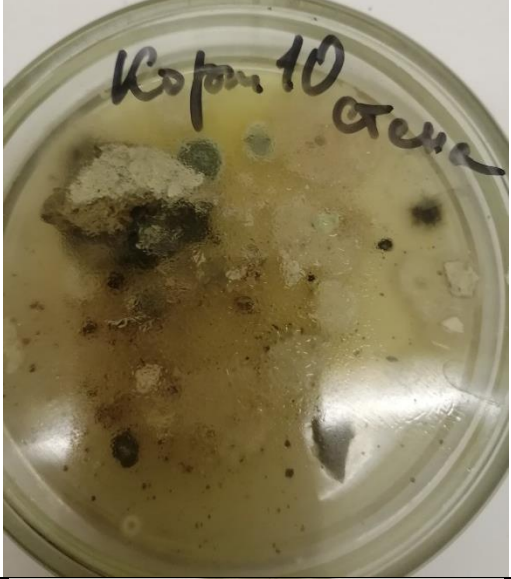
No.	Sample number	Species composition of microorganisms isolated from the surfaces of taken samples	Photos of fungi from concrete surface
1	Sample 10 (wall)	<p><i>Alternaria alternata</i>,  <i>Alternaria brassicae</i>,  <i>Penicillium chrysogenum</i>,  <i>Fusarium moniliforme</i>,  <i>Cladosporium elatum</i>,  <i>Chaetomium dolichotrichum</i></p>

Mycobiota of reinforced concrete structures of poultry building 10, maintained for 43 years (Table 4), is represented by 9 species from 7 genus: 2 species of *Alternaria* genus (*Alternaria alternata*,

*Alternaria brassicae*), 2 species of *Penicillium* genus (*Penicillium lanosum*, *Penicillium chrysogenum*), 1 species of *Fusarium* genus (*Fusarium moniliforme*), 1 species of *Cladosporium* genus (*Cladosporium elatum*), 1 species of *Chaetomium* genus (*Chaetomium dolichotrichum*), 1 species of *Mucor* genus (*Mucor corticola*), *Stachybotrys chartarum*. Among the fungi contaminating the surface of concrete structures of building 10, the fungi of *Alternaria*, *Penicillium*, *Stachybotrys*, *Cladosporium*, *Fusarium* genus are most often found. Micromycetes of such species as *Alternaria alternata*, *Penicillium chrysogenum*, *Penicillium lanosum*, *Stachybotrys chartarum*, *Fusarium moniliforme* are dominant.

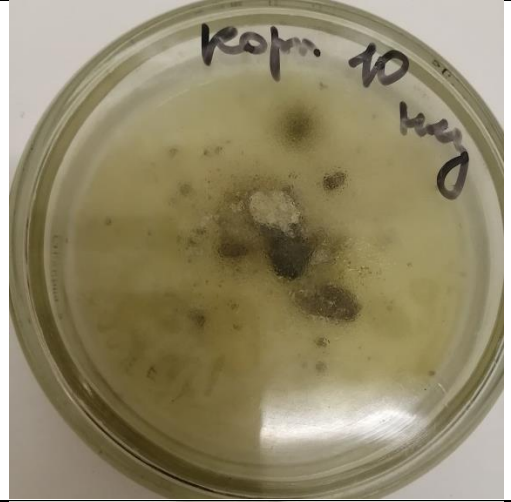
2	Sample 10 (bottom)	<p><i>Alternaria alternata</i>,  <i>Alternaria brassicae</i>,  <i>Penicillium lanosum</i>,  <i>Penicillium chrysogenum</i>,  <i>Fusarium moniliforme</i>,  <i>Cladosporium elatum</i>,  <i>Mucor corticola</i>,  <i>Stachybotrys chartarum</i></p>

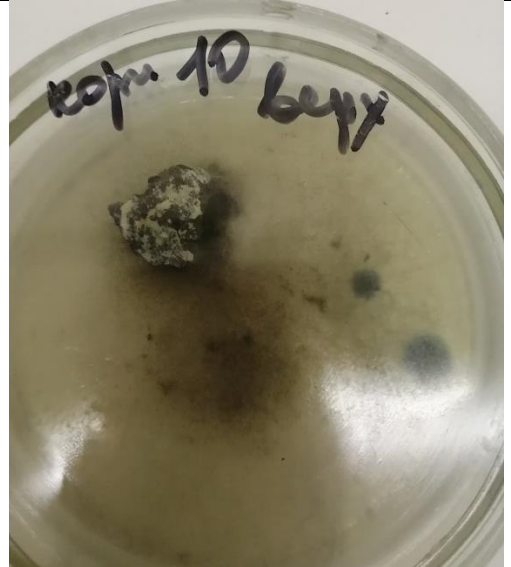
3	Sample 10 (top)	<p><i>Penicillium chrysogenum</i>,  <i>Penicillium lanosum</i>,  <i>Fusarium moniliforme</i>,  <i>Cladosporium elatum</i>,  <i>Chaetomium dolichotrichum</i>,  <i>Stachybotrys chartarum</i></p>

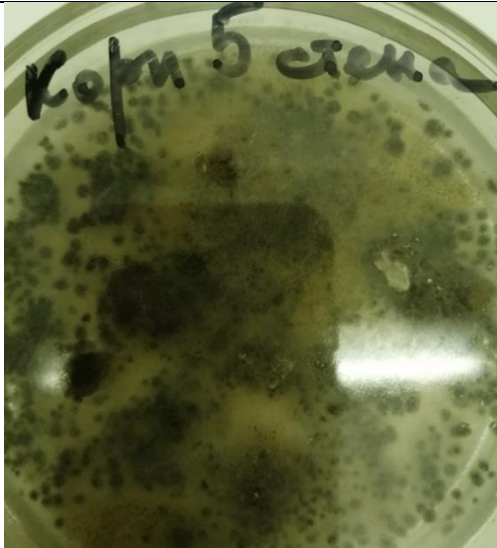
No.	Sample number	Species composition of microorganisms isolated from the surfaces of taken samples	Photos of fungi from concrete surface
1	Sample 5 (wall)	<p><i>Aspergillus oryzae</i>,  <i>Alternaria alternata</i>,  <i>Penicillium urticae</i>,  <i>Penicillium corylophilum</i>,  <i>Penicillium chrysogenum</i>,  <i>Penicillium notatum</i>,  <i>Penicillium lanosum</i>,  <i>Cladosporium elatum</i>,  <i>Cladosporium herbarum</i>,  <i>Mucor hiemalis</i>,  <i>Stachybotrys chartarum</i></p>

The species composition of micromycetes isolated from the surface of reinforced concrete structures of poultry building 5, maintained for 51 years (Table 5), is represented by 16 species from 8 genus: 2 species of *Alternaria* genus (*Alternaria alternata*, *Alternaria brassicae*), 1 species of *Aspergillus* genus (*Aspergillus oryzae*), 6 species of *Penicillium* genus (*Penicillium corylophilum*, *Penicillium chrysogenum*, *Penicillium tardum*, *Penicillium urticae*, *Penicillium lanosum*, *Penicillium notatum*), 1 species of *Fusarium* genus (*Fusarium moniliforme*), 2 species of *Cladosporium* genus (*Cladosporium herbarum*, *Cladosporium elatum*), 1 species of *Chaetomium* genus (*Chaetomium dolichotrichum*), 2 species of *Mucor* genus (*Mucor corticola*, *Mucor hiemalis*), 1 species of *Stachybotrys* genus (*Stachybotrys chartarum*). Among the fungi contaminating the surface of the concrete structures of building 5, fungi of *Alternaria*, *Penicillium*, *Cladosporium*, *Stachybotrys*, *Mucor* genus are the most common. Dominant species isolated from reinforced concrete structures of poultry building 5 are such micromycetes as *Alternaria alternata*, *Penicillium chrysogenum*, *Penicillium lanosum*, *Cladosporium elatum*, *Stachybotrys chartarum*.

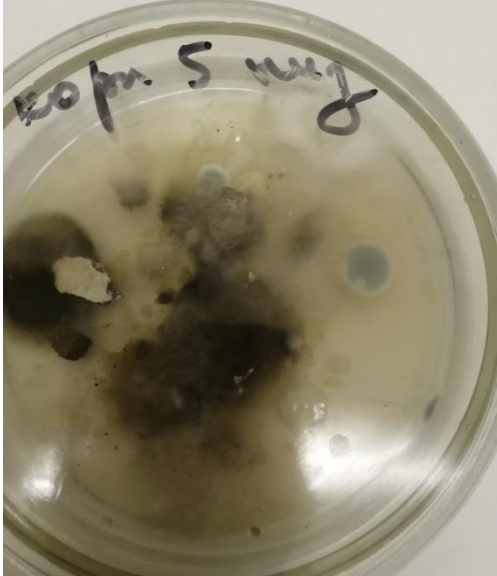
2	Sample 5 (bottom)	<p><i>Alternaria brassicae</i>,  <i>Alternaria alternata</i>,  <i>Penicillium chrysogenum</i>,  <i>Fusarium moniliforme</i>,  <i>Cladosporium elatum</i>,  <i>Chaetomium dolichotrichum</i>,  <i>Mucor corticola</i></p>

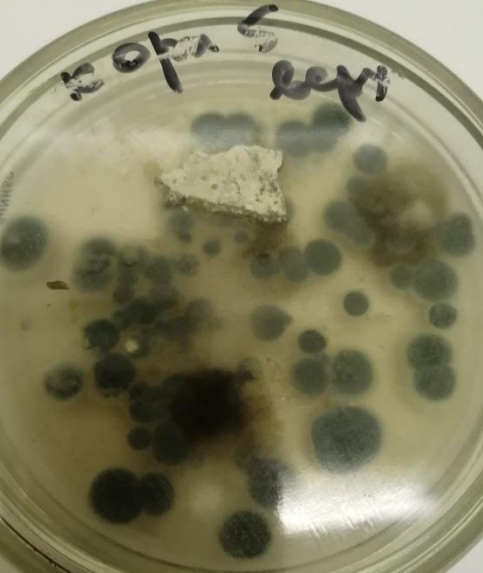
3	Sample 5 (top)	<p style="text-align: center;"> <i>Alternaria alternata</i>,  <i>Alternaria brassicae</i>,  <i>Penicillium corylophilum</i>,  <i>Penicillium chrysogenum</i>,  <i>Penicillium tardum</i>,  <i>Penicillium urticae</i>,  <i>Penicillium lanosum</i>,  <i>Penicillium notatum</i>,  <i>Fusarium moniliforme</i>,  <i>Chaetomium dolichotrichum</i>,  <i>Mucor corticola</i>,  <i>Stachybotrys chartarum</i> </p>
